Evaluation of Visibility Sensors at the Eglin Air Force Base Climatic Chamber

Dr. David C. Burnham

Transportation Systems Center
Cambridge MA 02142

October 1983
Final Report

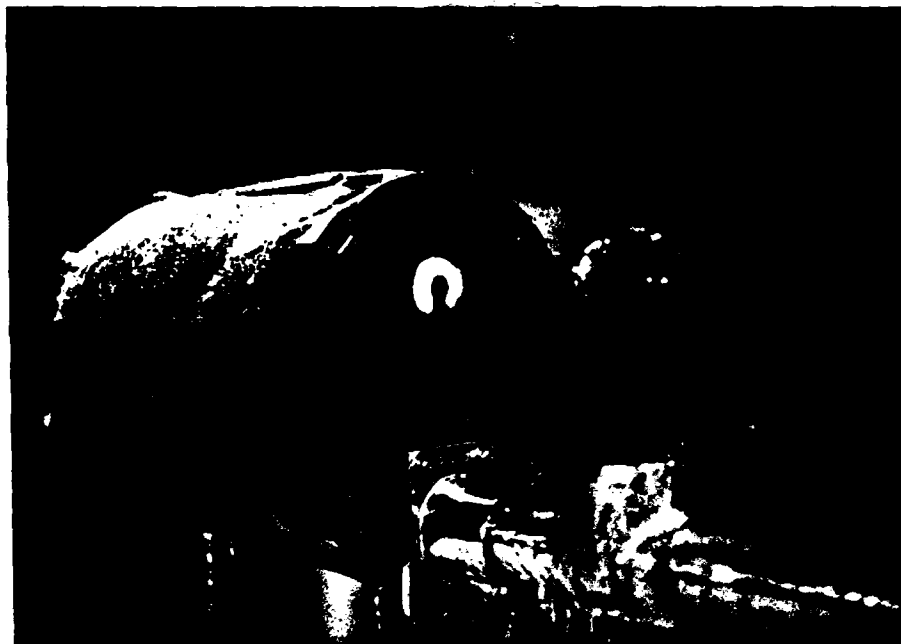
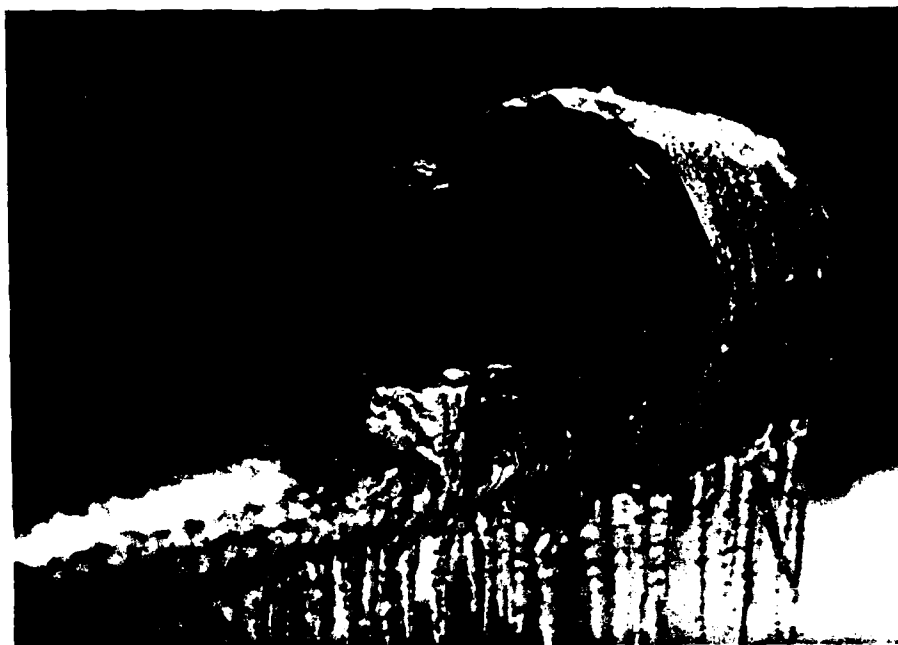
FIGURE 5-8. WRIGHT & WRIGHT FOG-15 FORWARD-SCATTER METER:
(a) IN SNOW, (b) IN FREEZING RAIN, (c) PROJECTOR, (d) RECEIVER.

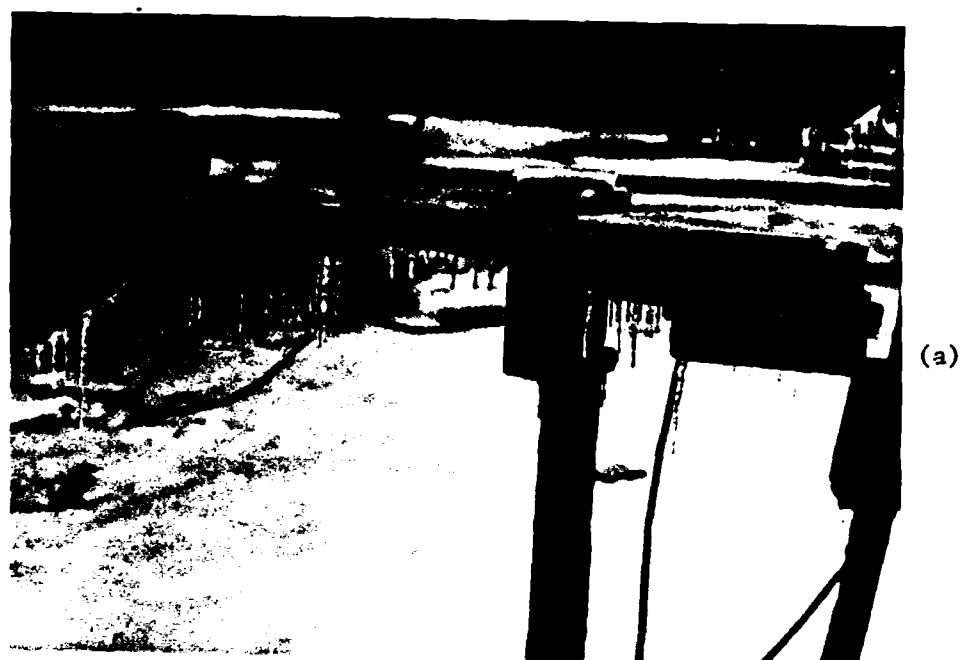
FIGURE 5-9. HSS VR-301 FORWARD-SCATTER METER:
(a) BEAM BAFFLE ON LEFT, (b) SCATTERING GEOMETRY.

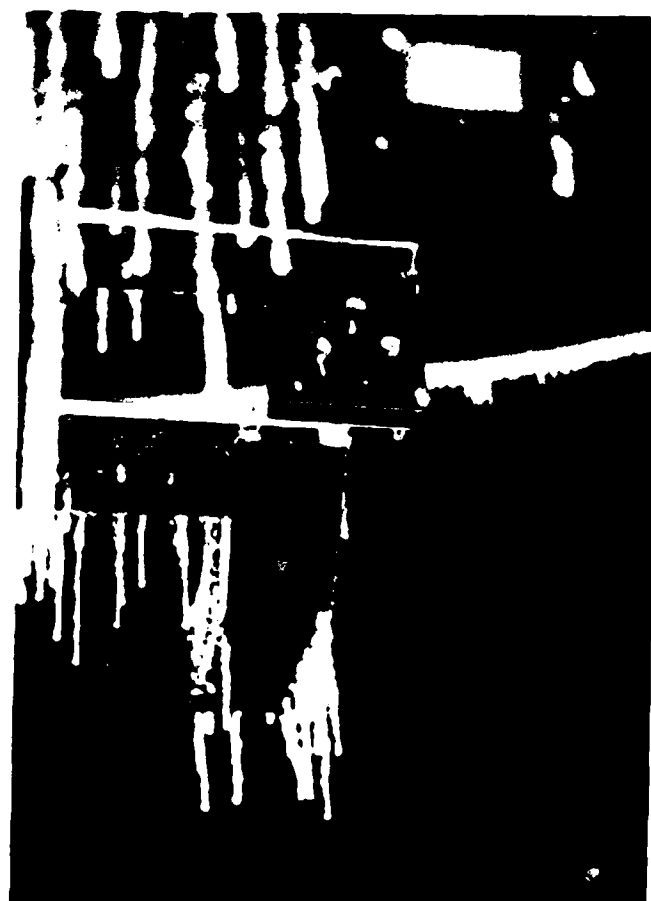
FIGURE 5-10. IMPULSPHYSICS FUMOSENS III FORWARD-SCATTER METER:
(c) IN SNOW, (d) IN FREEZING RAIN.
